Lacamas Lake Restoration Program: WY 2000 and WY 2001 Water Quality Monitoring

Clark County Public Works Water Resources Section

March 2002

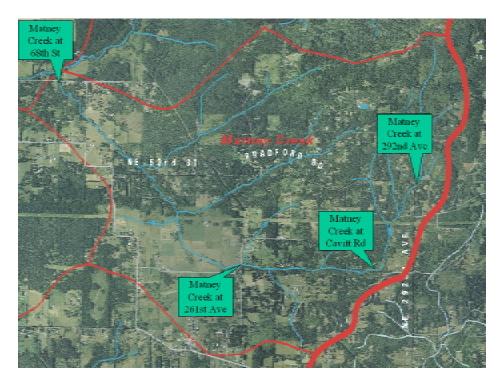
$Figure\ 2.\ Matney\ Creek\ habit and\ benthic\ macroinvertebrate\ monitoring\ sites,\ 2001.$

Figure 1 depicts the location of the Matney Creek and Dwyer Creek subwatersheds within the Lacamas Creek watershed. Figure 2 and Figure 3 show the locations of the Matney and Dwyer subwatershed monitoring sites, respectively.

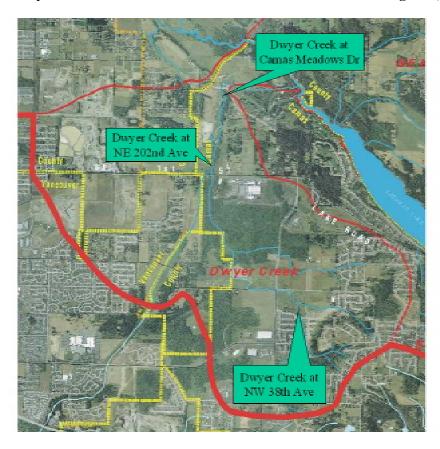
Figure 3. Dwyer Creek habitat and benthic macroinvertebrate monitoring sites, 2001.
